Root Cause Analysis of Cracking in Shaft End and Coupling of a High-Power Generator

Abstract Failure analyses and root cause determination were carried out on the rotor of a high-power generator of gas–diesel dual fuel which presented cracking due to torsional fatigue in its end (region of section change and coupling), after 30,000 h of service. The generator of 307 MW–3000 rpm has a rotor (shaft of 400 mm Ø) manufactured in a proprietary steel grade equivalent to ASTM A470 type, Class 7 of high hardenability. It was reported that the equipment control system showed, in service, a high level of vibrations, not admissible for continuing the operation. First, and during the equipment shutdown for inspection, the presence of cracks, slant to the rotor shaft, was detected by means of visual inspection and dye penetrant test. The failure region corresponds to the zone of coupling–shaft joint, linked by means of fixation by interference, whereas the cracking spread on two fracture planes at 45° with respect to the rotor shaft. On this zone, where cracking started, a severe fretting corrosion damage was evidenced. The characterization and identification of present damage mechanisms were

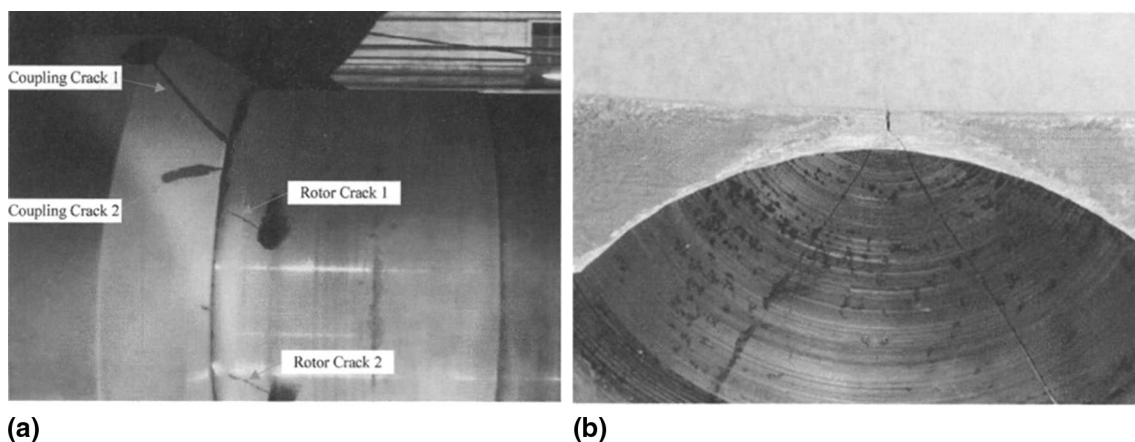
Since 1970, several shaft failures have been detected and frequently placed in the coupling region associated with a fatigue fracture started with a surface *fretting* damage that, in turn, in most cases showed the presence of torsional vibrations (Fig. 1).

Fig. 1 Fatigue fracture failure in a shaft and coupling of high-power generator. “Coupled torsional vibration and fatigue damage of Turbine Generator Due to Gird Disturbance.” Chao Liu y Col. Beijing, China. 2014

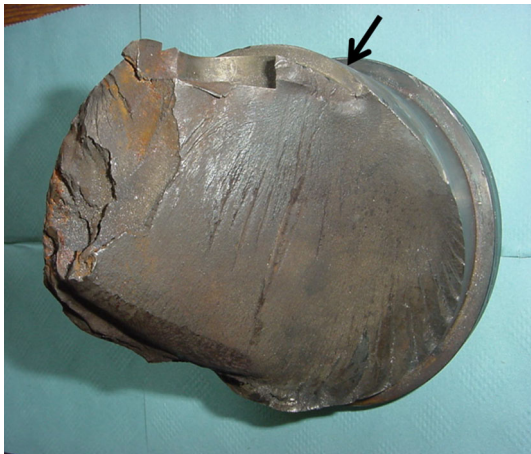
Fig. 2 Generator shaft and coupling with evidence of a torsional fatigue fracture. Craighead and Gray [4] investigation of diesel generator shaft and bearing failures

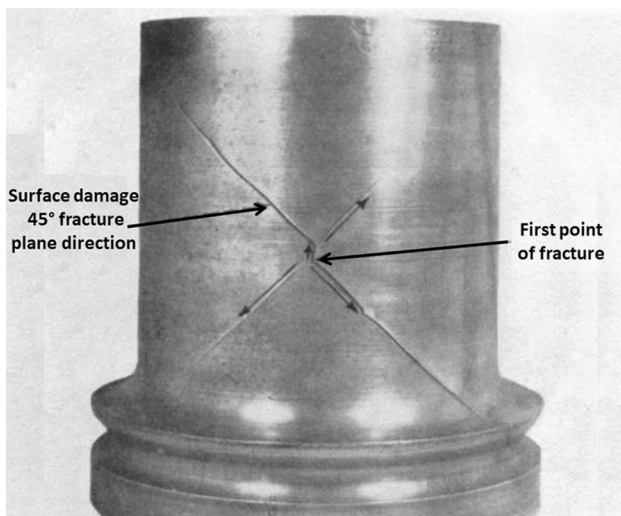
formed at 45° with respect to the shaft longitudinal direction [5]. Figure 3 shows a shaft with fracture by torsional fatigue with inversion in the rotating direction started in circumferential marks (damage by *fretting*). In the presence of that kind of pattern, and as long as the element does not have a load inversion assigned in service, there will be torsional vibrations [3, 5].

Fig. 3 Fracture in X (starburst pattern) due to the presence of inversion of torsional loads. “Fatigue Failures, With Special Reference to Fracture Characteristics,” G. A. Cottell, M.Sc., A.I.M. 2004 ASM International

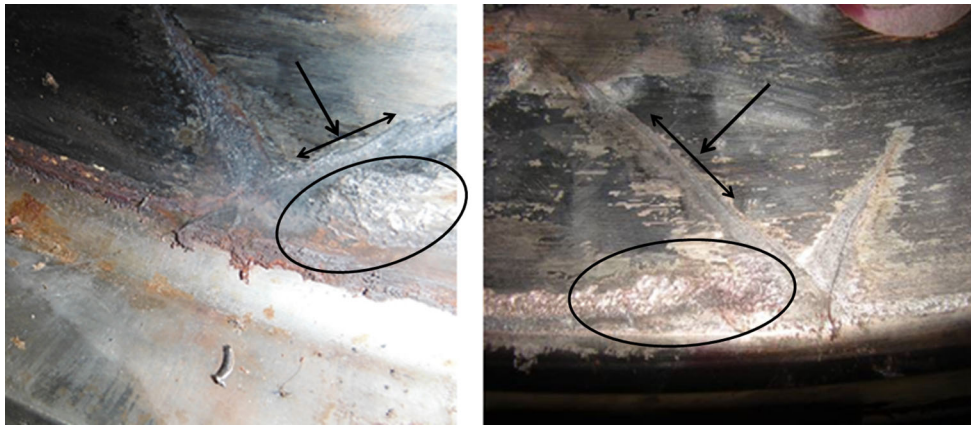
Once defined the cracking location by end, the shaft was axially cut for then analyzing the fracture surface. Figure 4 shows, both in the shaft and coupling, the fracture pattern where the arrow points out the main propagation plane in the shaft and coupling. In these zones, a severe damage by *fretting corrosion* is evidenced, which has the same topographic characteristics of damage in part and counterpart of

what was the stationary interference fitted joint. It is observed in both part and counterpart (shaft and coupling), and the presence of a main plane of fracture propagation at 45° from the longitudinal axis of the element and, in turn, an incipient fracture plane developed orthogonally to the main plane, typical feature of a load state with reversing torsional stresses.

Fig. 4 Cracking of shaft (left) and coupling (right) before opening fracture surfaces. Cracking is pointed out in arrows (with the main fracture plane indicated in black) and fretting damage circled

The most detrimental effect of damage by *fretting corrosion* is that it can lead to *fretting* fatigue (fractures by fatigue due to fretting). In the case of shafts, fractures can be of bending or torsional type or combined. Torsional fatigue fractures are typically oriented at 45° with respect to the axial direction, whereas bending ones at 90°. If there are two fracture planes at 45° in a shaft whose nominal load does not change direction (the case under study), this is an indicator of torsional vibrations (Figs. 4 and 5).

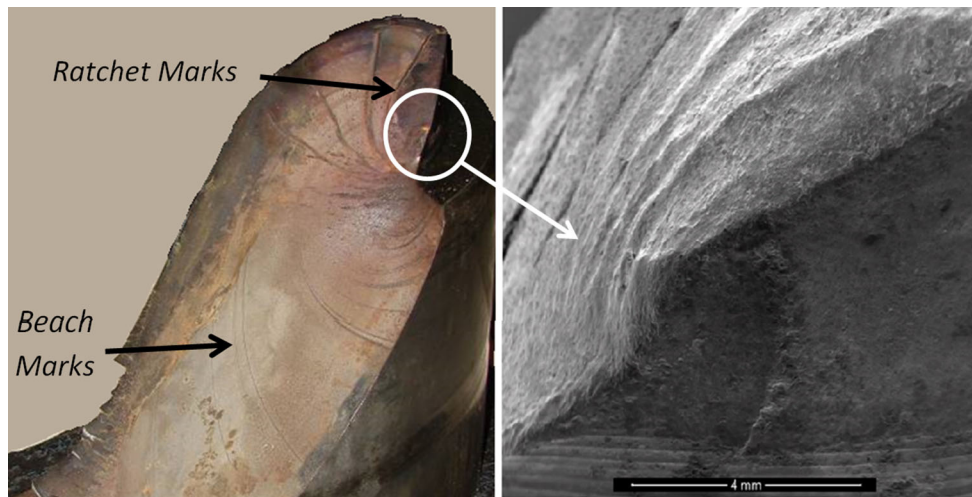
Figure 5 shows how the crack opening exposed the fracture with the characteristic pattern of a propagation by fatigue, where *ratchet marks* are pointed out together with *beach marks* in black arrows and the fracture origin is circled. On

the right, the region of fracture (enlarged by SEM) is seen where a severe damage by *fretting* (shaft surface) can be observed and, on the other hand, the concentric advance marks of the fracture plane at the beginning of the failure are observed.

Fig. 5 Left: shaft fracture surface where it is observed the pattern of fracture by fatigue. The beginning of fracture is indicated with a circle. Right: SEM image where the region of fracture origin is seen

- Shaft cracking is typical of a fracture by torsional fatigue of high-cycle, low nominal-strain regime (fatigue propagation zone with *beach marks* occupies a surface over 300 mm long), developed from the shaft fillet radius. Cracking spread on two fracture planes at 45° with respect to the shaft axis.

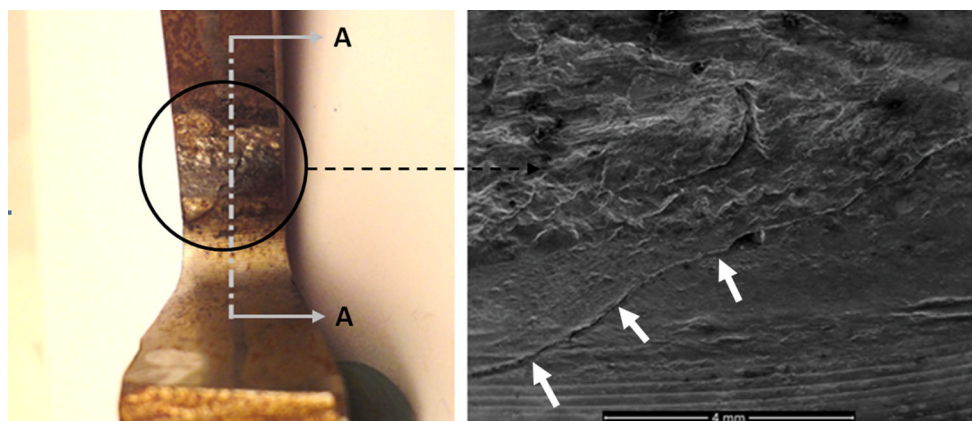
Figure 6 shows a shaft section with fretting damage; on the right image it the machining marks and deformation resulting from the micro-movements present in the stationary joint can be observed via SEM, and also a crack (indicated in black) crosses the image from the region with *fretting* to the zone where the machining roughness still persists.

Fig. 6 View of the surface affected by fretting via SEM. On the right image, the machining and deformation marks can be observed. On the left image, the cross section performed for the transversal view of damage by fretting is indicated

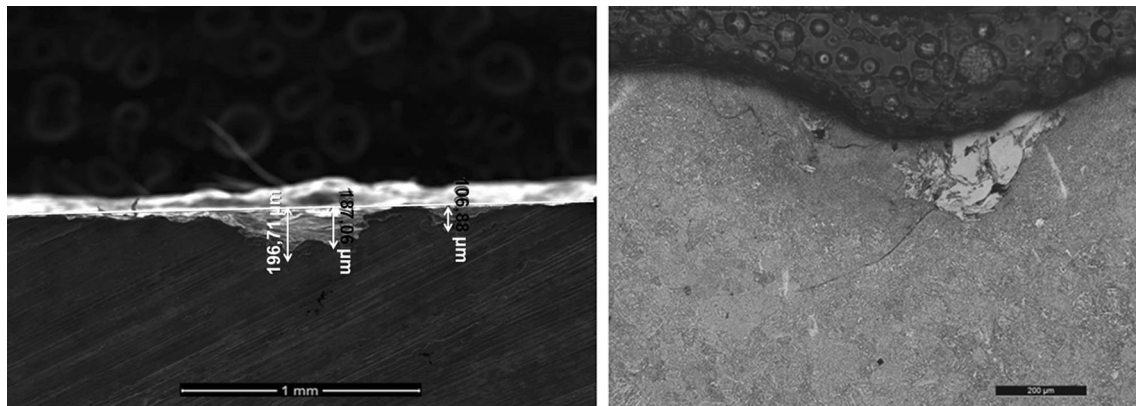
Besides, Fig. 6 shows the section A-A that will be presented as a micrograph transversal to the fretting damage, showing severe alterations (Fig. 7), where deformations, with a depth in the order of $200\ \mu\text{m}$, and intrusions of wear particles (debris) corresponding to the shaft and coupling steel, together with oxides and possibly lubricant remains, are observed.

Fig. 7 View of cross-section A-A shown in Fig. 6. Fretting damage is evidenced with a depth in the order of two-tenths of millimeter. The right micrograph shows the presence of the counterpart metal as well as a severe damage by deformation
