Field measurements and modelling of high frequency transients during disconnect switch operations in EHV Substations. Assessment of their effects on Current Transformers

M.D. DEL POZO D.A. ESTEBAN P.E. ISSOURIBEHHERE G.A.BARBERA
IITREE FI-UNLP
Argentina

A. FUNES A. LEDESEMA
YACYLEC
Argentina

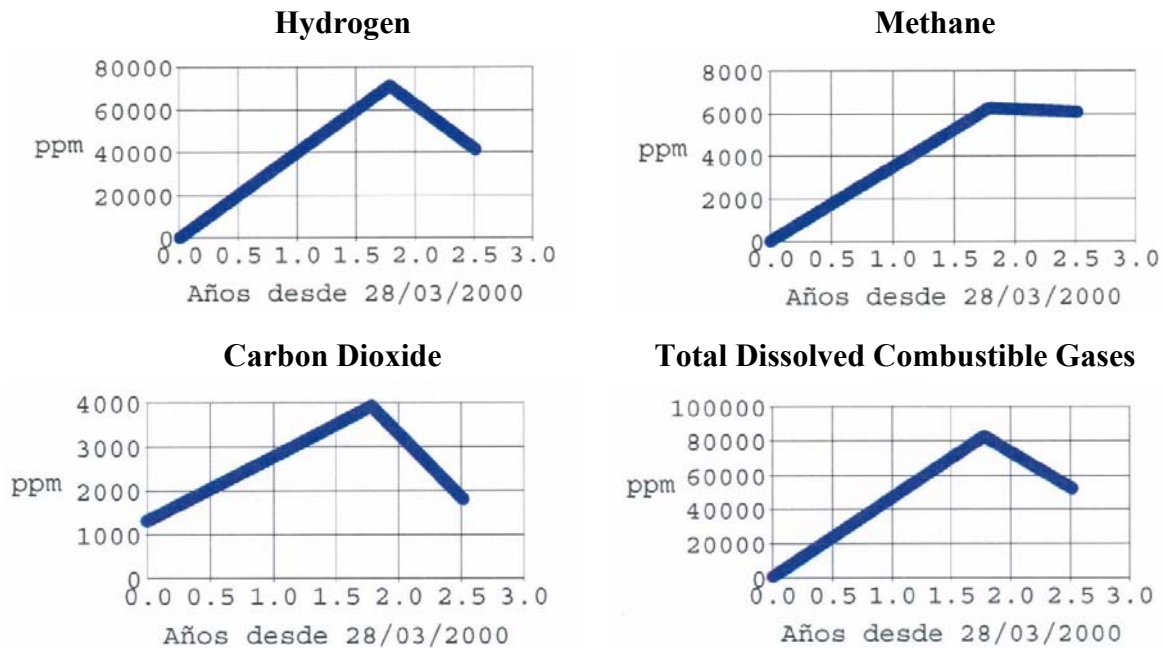
Figure 1. Results of gases analyses performed in oil.

The charts indicate the levels of gases in **parts per million [ppm]** as a function of time. In all the cases the amount of gases increased dramatically between the analyses carried out in March of 2000 and the next ones performed after the CT was taken out of service, in January of 2002. After that, personnel of the Company continued taking samples of oil and performing the same corresponding analyses. For this reason, the trends decrease once the peak has been reached.

In order to determine the presence of gases a sample of oil was taken and then chromatographically analysed. By the tests performed to the sample of oil it was detected a severe increment in the amount of several gases: hydrogen, methane and carbon dioxide, among them. In Fig. 1 the results of the chromatographic analyses are shown. It has also been included the Total Dissolved Combustible Gases (TDCG).

Naturally, such an increment in the amount of gases in the oil evidenced a possible damaged in the CT insulation. Because of this reason, several CTs were taken out of service.

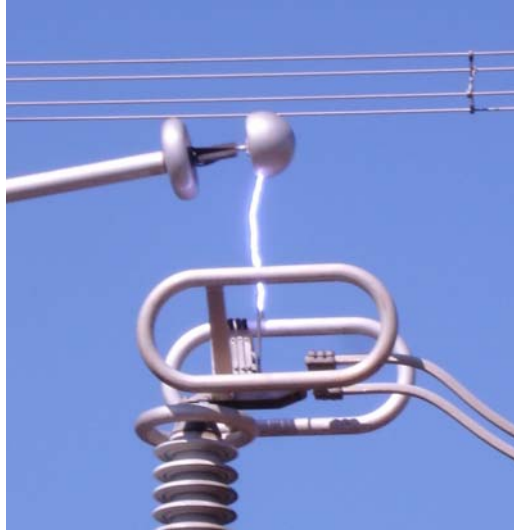
Figure 2. Arc present in the air disconnect switch during an operation.

Additionally, it was also essential to determine the reasons for this premature damage. It was immediately thought that a possible cause of this could be the electrical stress that CTs suffer during air disconnect switch operations. It consists of high-frequency transients that arise in CTs while the arc is present in the disconnect switch. They take place in both opening and closing operations. Photograph in Fig. 2 shows the very moment in which the arc is present.

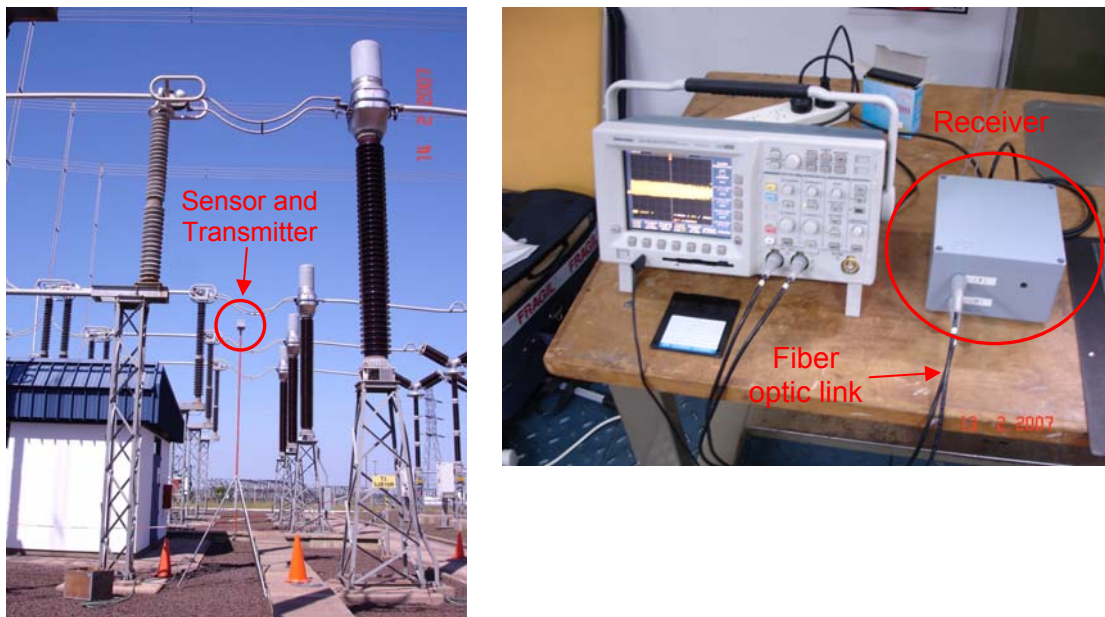
A specially designed measuring system was utilized to carry out field transient measurements. This system basically consists of an electric field (E) sensor, an E/V transducer, and finally a transmitter and a receiver connected by a fiber optic link. The signal arriving at the receiver can be easily observed with either an oscilloscope or a spectrum analyzer. Its bandwidth is from 5 Hz to 10 MHz. In Fig. 3, some photographs of the system are shown.

Figure 3. Photographs of the measuring system.

The main advantage of this measuring system lies in the fact that measurements can be performed without affecting the normal operation of the substation since it has no physical contact with the installation. Added to this, due to the fiber optic link, measurements are not affected by the electromagnetic noise present in the substation.

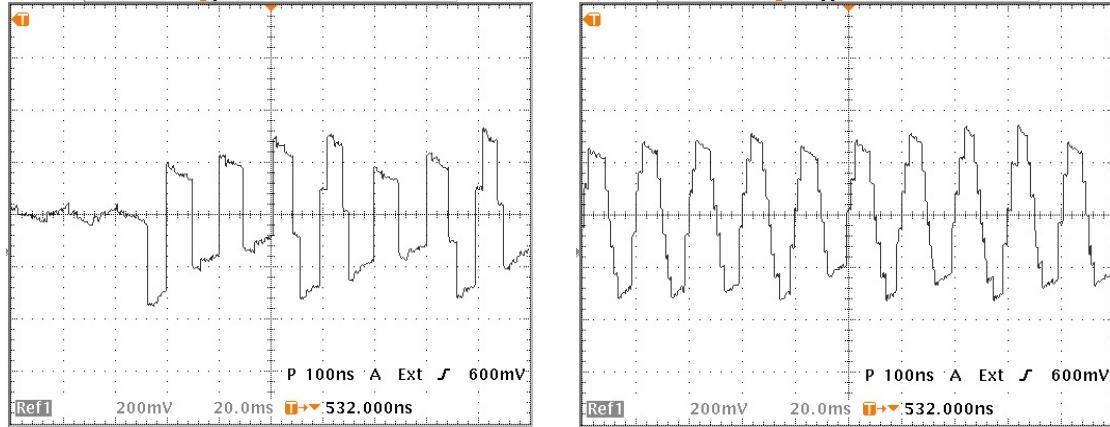
In Fig. 4 two oscillograms belonging to a closing operation in Field 1 are depicted. The first one was captured at the beginning of the arc, whereas the second was obtained 790 ms after the arc began.

Figure 4. Oscillograms during closing operation. At the beginning and close to the end of the arc.

As it can be observed in both graphs the perturbation due to the arc in the disconnect switch does exist and appears on the CT. At the beginning of the arc voltage steps of great amplitude, which only occur twice, one positive and another negative, during each period of the power-frequency are present. On the other hand, close to the end of the arc, as its length is reduced, the steps are of smaller amplitude than at the beginning, but their amount is greater during each period of the power-frequency.

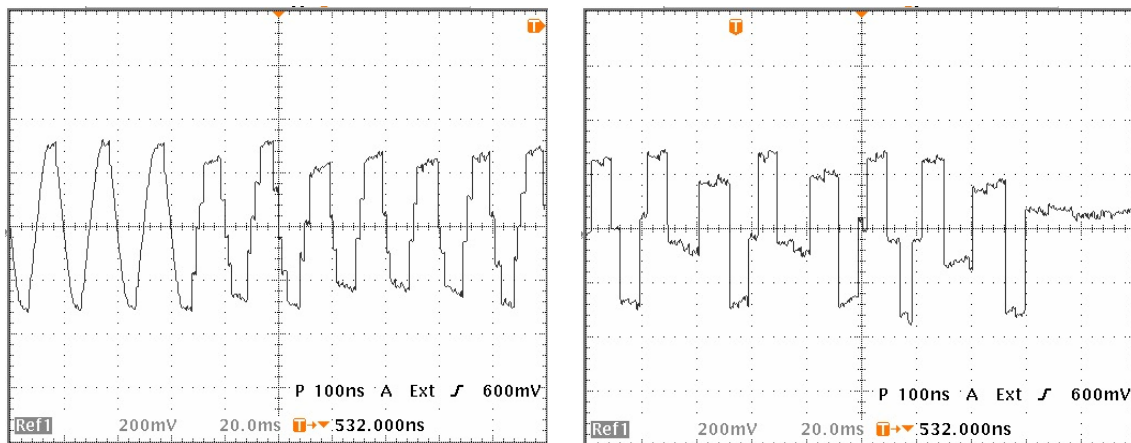
In Fig. 5 two oscillograms obtained during an opening operation are shown. The comments are analogous to those made in the previous case, but now the voltage steps of great amplitude take place at the end of the arc, while those of smaller amplitude appear at the beginning.

Figure 5. Oscillograms during opening operation. At the beginning and at the end of the arc.

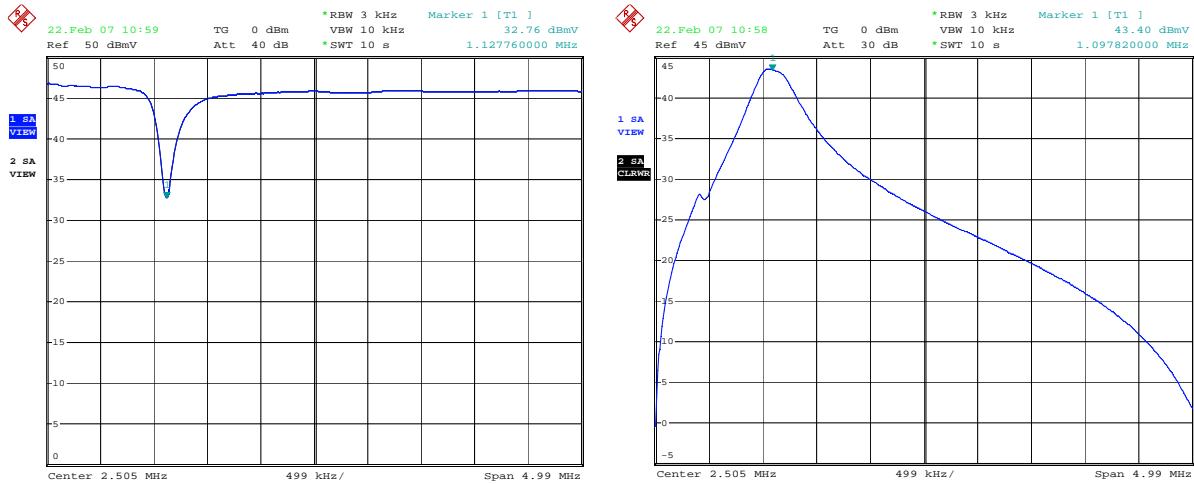
In Fig. 6 both voltage and current measured spectrums are depicted. These responses also include contribution of the measuring circuit (coaxial cables, etc.).

As it can be seen, the resonant frequency lies in 1.127 MHz. In addition, the total equivalent series resistance is 7.46 Ω .

Figure 6. Spectrums of voltage and current of a CT between 10 kHz and 5 MHz.

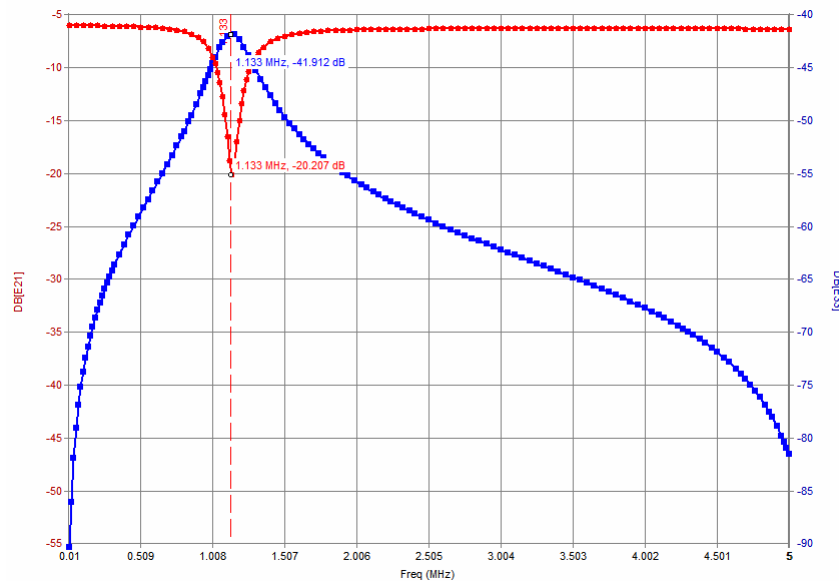
Then, the complete circuit was drawn in the simulation program. The values of C_t , L_s and R_s were determined by trial and error, i.e. they were adjusted many times until the simulated responses matched the measured ones. As a result, it was achieved that $C_t=1$ nF, $L_s=4,4$ μ H and $R_s=6,5$ Ω .

In Fig. 7 the responses obtained by simulations are depicted (voltage in red and current in blue). Thus, it has been proved that the model achieved for the CT and the measuring circuit works successfully.

Figure 7. Responses achieved by simulation, tuning the values of the components.

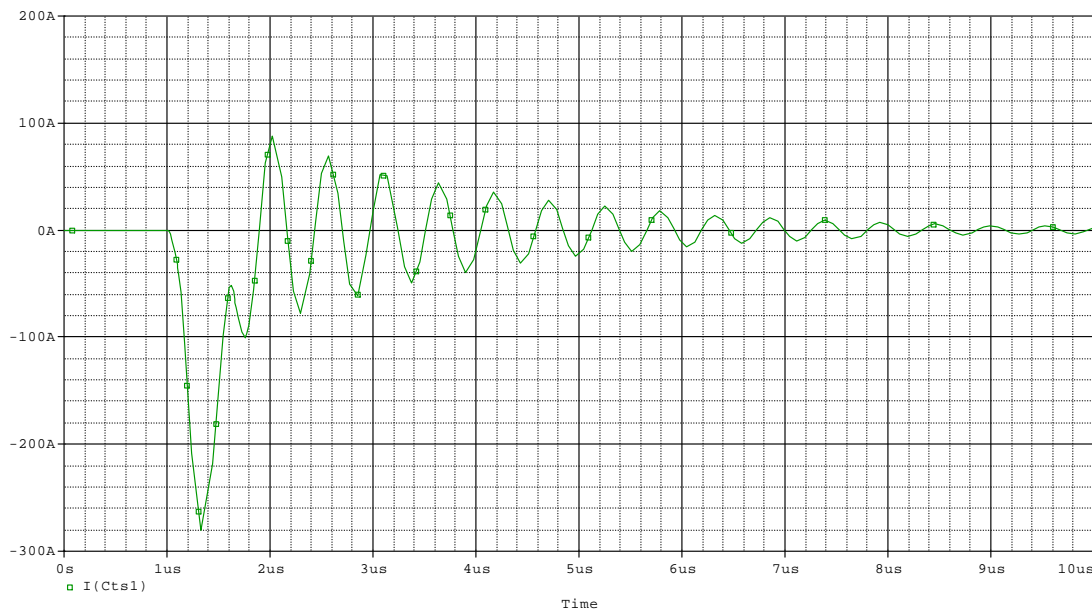
The result of one of the simulations carried out appears in Fig. 8. As expected, the current resulted in a damped oscillation, whose oscillation frequency is 1.9 MHz. It is worth remarking that its amplitude is reduced to less than 10 % of its maximum value at $6\text{ }\mu\text{s}$ after the transient begins. In addition, the current peak reached a value of 280 A for each 100 kV of the step voltage amplitude.

Figure 8. Current through CT to ground.

By using the conversion factor of 2.80 A/kV and the actual magnitudes of the different voltage steps recorded it was possible to determine the maximum and the average values of the peak currents that would be expected. These are 1206 A and 1060 A, respectively.

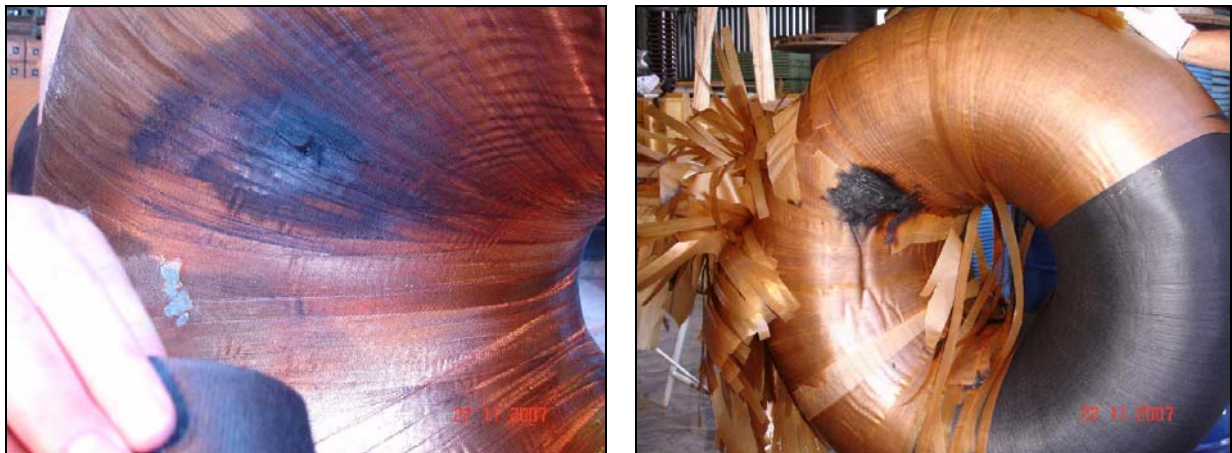
As soon as the disassembly of this part began it was possible to observe some damage in **S1** layer. The metallic had been noticeably affected by internal discharges. Once **S1** was removed, some severe damage was also observed in the oil-impregnated paper located between **S1** and **S2**.

In Fig. 9 photographs of the metallic layer and the paper are presented. Both pictures show clearly the damage caused by the electrical stress to which the isolation was subjected to.

Naturally, the level of the stress was high enough to “carbonize” the paper. Normally, discharges occur at the edge of the layers, but they can propagate rapidly in oil-impregnated paper.

Figure 9. Metallic layer and paper affected by internal discharges.

This “puncture” on the insulation of the CT is thought to have been caused by the high-frequency transients that were dealt with in the previous sections. Discharges are presumably initiated at the edge of a layer with the first operations, but in the long term they can result in considerable propagation, extending through several layers of paper. If these anomalies are not detected at the correct time, they could lead the Current Transformer to complete breakdown.

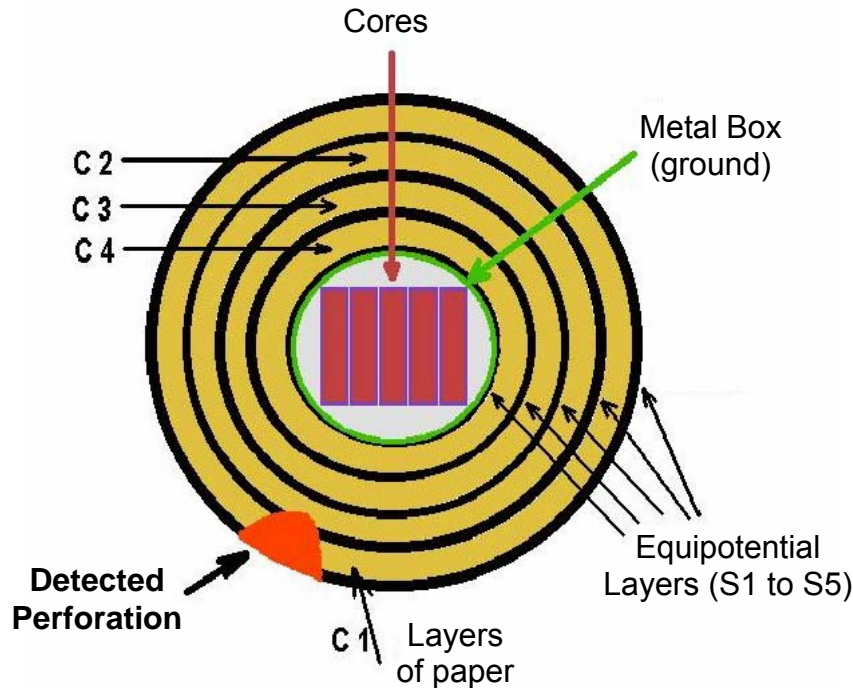
In the schematic drawing of Fig. 10 it is represented the area where the main damage of the insulation was located.

Figure 10. Schema showing the area affected by the perforation.
