# MICROSCOPY APPLIED TO BIOFILMS IN DRINKING WATER CLOSED LOOP

**SUMMARY:** During water distribution operation, tubing material is submitted to permanent contact with aquatic microbial species. They colonise the network surface forming biofilms which frequently cause corrosion on metallic substrata. The present study approaches the analyses of laboratory biofilms formed on water pipe materials from several (SEM, ESEM, CLSM) microscopy technique point of view and also from a microbial ecological analysis using DGGE for the study of the communities formed on each substrate. Microbial interactions with the different materials were described using an ample range of magnification. Three commercial metals (Fe, Zn, Cu) and polypropylene tubing used as substrata revealed very different behaviours. Even when it was possible to distinguish different attack morphologies and the biofilms 3-D structures formed on all materials it was not already established a clear correlation with the genetic profile of each community.

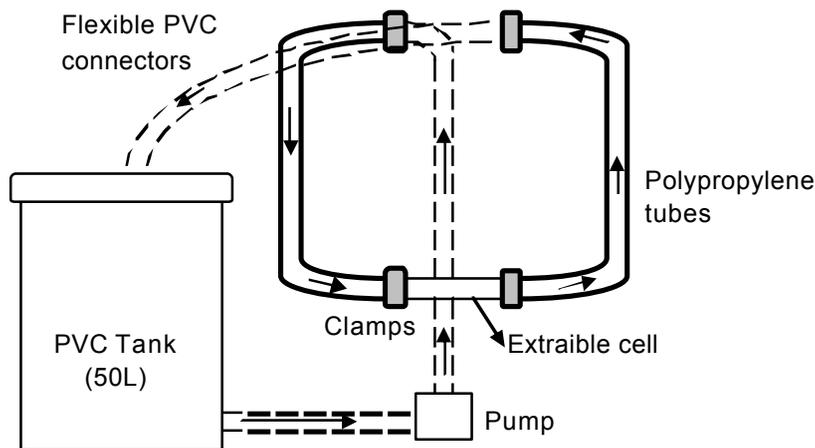
A laboratory simulated distribution system (Fig.1), with the drinking water flowing at laminar flux alternatively 30/60 minutes work/stop periods to simulate a domestic network operating cycles was used. After 30 days test period a transparent support with 7 replicates of each of the 4 materials was extracted in sterile conditions from the loop.

Figure1. Scheme of the drinking water closed loop.

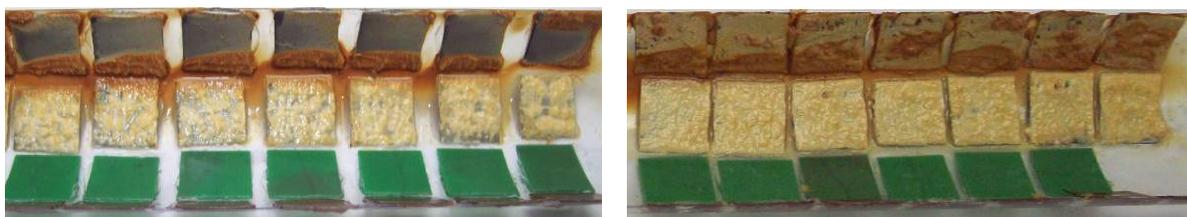
Since the beginning of water circulation test, heterogeneously distributed microbial colonisation could be observed on all exposed materials. After some days, mixed up with the biofilms and biological EPS deposits, increasing amounts of corrosion products and spurious solids coming with the drinking water appeared especially on Fe and Zn samples. At the end of each test series the aspect of deposits presented very scattered distribution amongst all the materials replicates (Fig.2).

Figure 2. Heterogeneous aspect of deposits on extracted samples from two test series

The uneven aspect at the naked eye of samples retired after circulation test (Fig. 2) suggested the need of surface morphological biofilms analysis at diverse magnification and also through cuts in deepness. Using CLSM inner structure deconvolution was performed on randomly selected sites at a fixed depth as in sequences shown in Figs. 7 and 8.

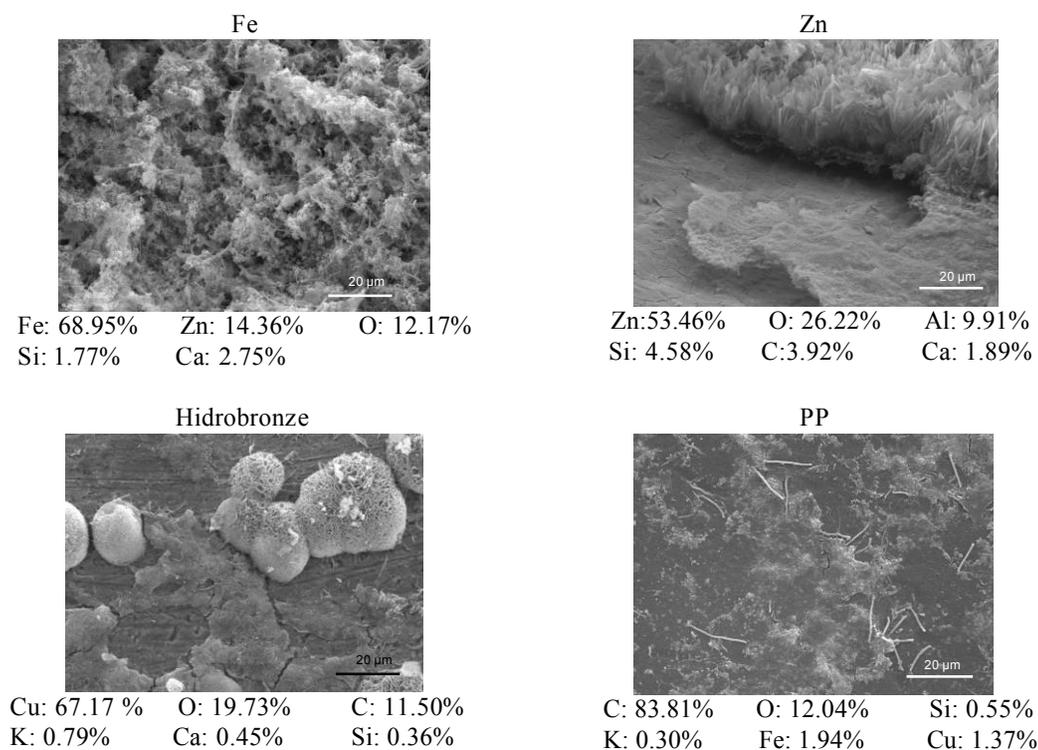
Starting with a stereoscopic magnifier at 40 x the aspect of various steps were appreciated during biofilm formation on Fe and Zn, characterised by two or more superposed phases, separated by a cleavage plane. The outer phase is much thicker presenting a blistered structure and a space between the inner phase and the metal substrata can be appreciated. Details were further observed with SEM-EDAX up to 1,000 x on all materials showing a single phase biofilm on hidrobronce and PP. At the latter magnification also microorganisms colonizing bare surface areas could be clearly seen in Fig. 3.

The EDX composition of spheroid structures observed on the hidrobronce biofilms revealed  $\text{Cu}_2\text{O}$  formation and water contaminants.

Figure 3. Colonization of materials samples exposed to drinking water circuit and EDS.

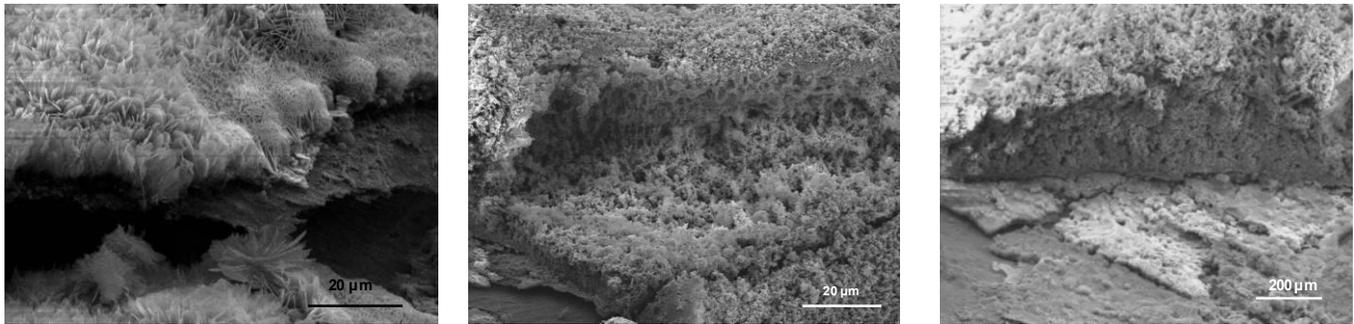
Very diverse aspects in cross section, revealed by a 45° SEM stage tilt, showed structures corresponding to various compounds on the different material surfaces, especially evident on Zn (Fig. 4).

Figure 4. Deposits on Zn samples.

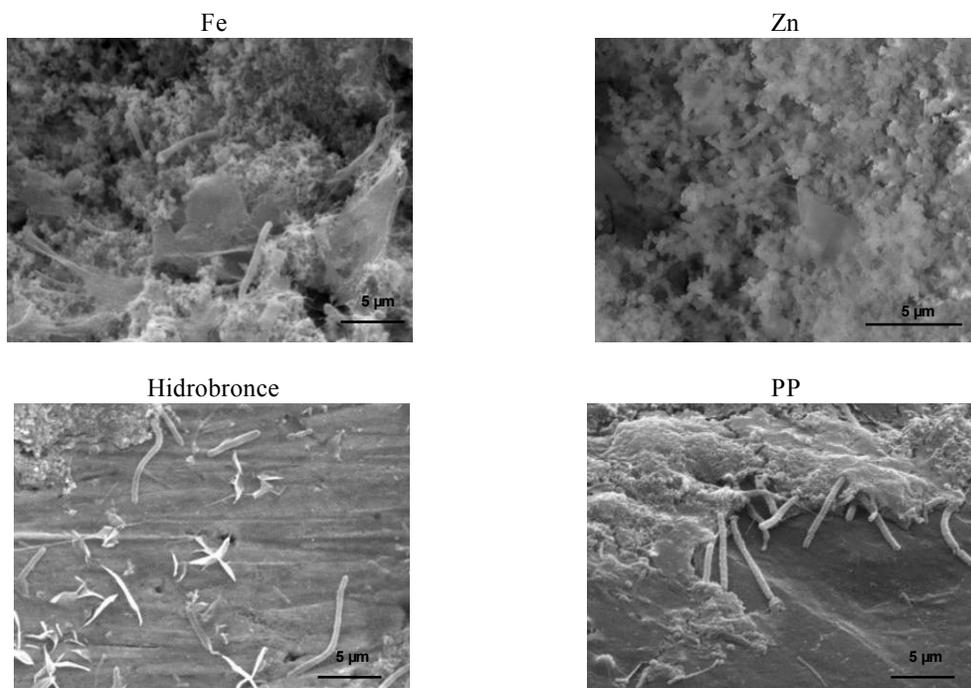
All tubing material samples showed bacterial presence in contact with each material substratum (Fig. 5). That allowed a close correlation with soft metallic attack. This contact showed evidence of very diverse structure on the respective failure induced, being possible to appreciate the low aggressiveness detected on several metals.

Figure 5. Bacteria in biofilm in contact with material substrata.

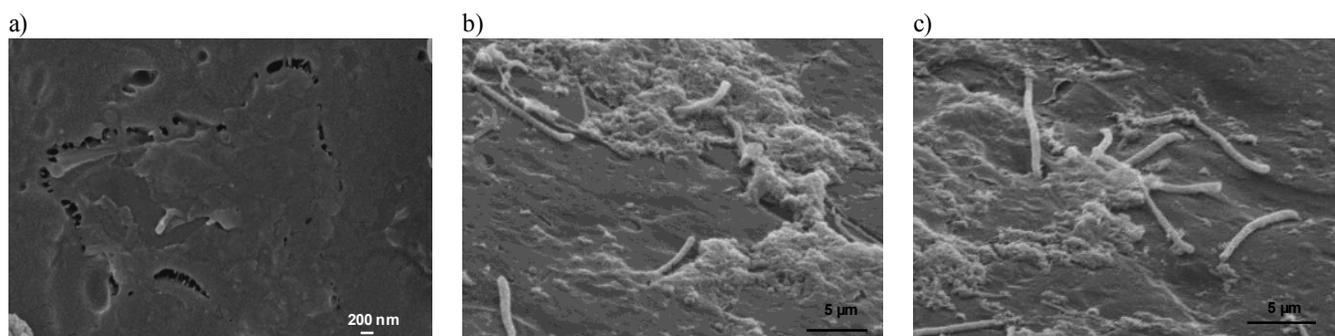
Respect to PP the thinnest single phase biofilm was observed, similar to the external phase formed on metallic substrata. Its low thickness allowed detecting isolated microbes at the biofilm bottom in contact with the substratum material as can be seen in Figs. 6 b)-c). Comparing with non exposed material in (Fig. 6 a) the surface failures detected near to microbial cells could not be attributed to microbial effects, but to spurious deposits and corrosion products from the other materials.

Figure 6. a) PP surface original defects. b)-c) Single biofilm on PP. Microbes in contact with the substratum.

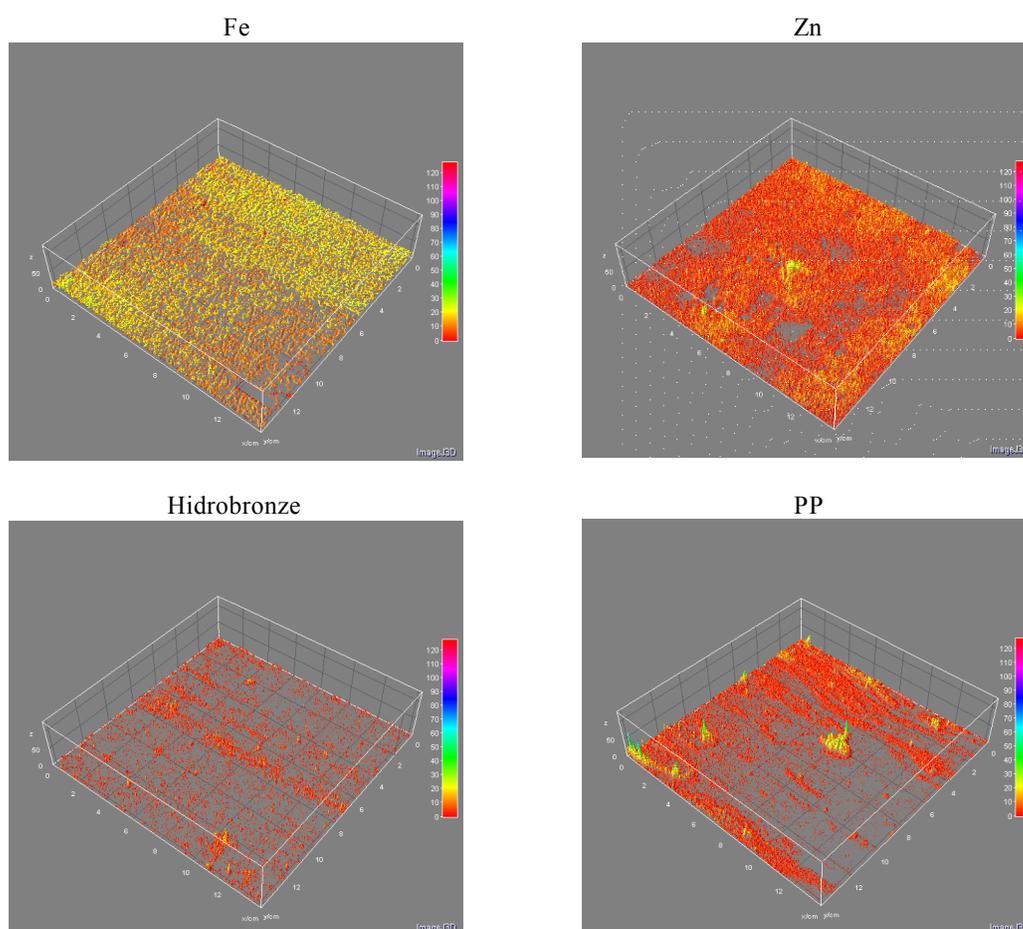
Biofilms formed on all tubing materials showed to be very heterogeneous amongst replicates. Morphology along biofilms, as particle form, size and relative density revealed different distribution on random areas of each material as shown in Fig. 7. Single images at various deepness taken along biofilm profile showed evidence of different cells spatial distribution (Fig. 8).

Figure 7. 3-D structure of biofilm formed on all materials after exposure to circuit.

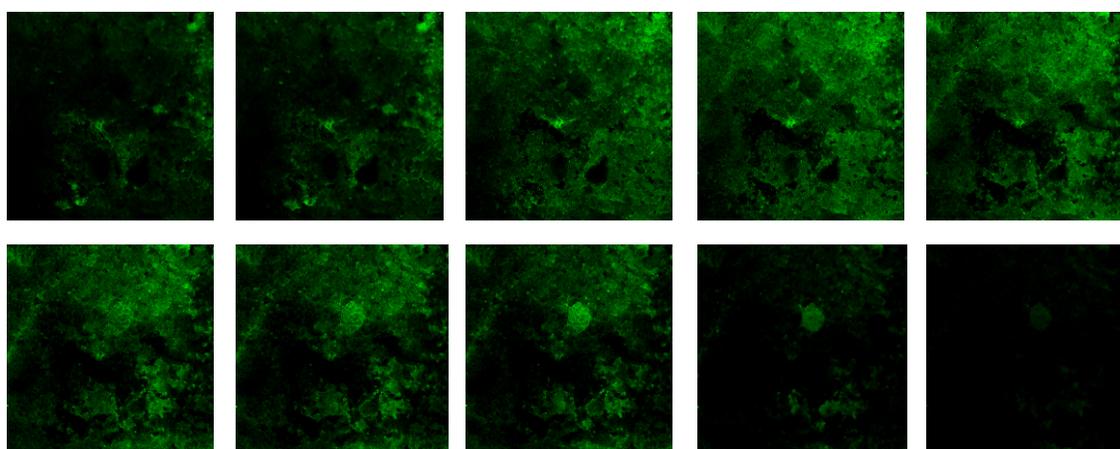
Figura 8. Space-time on a randomly chosen area of a biofilm on Zn by CLSM sequence selected amongst 34 slices.

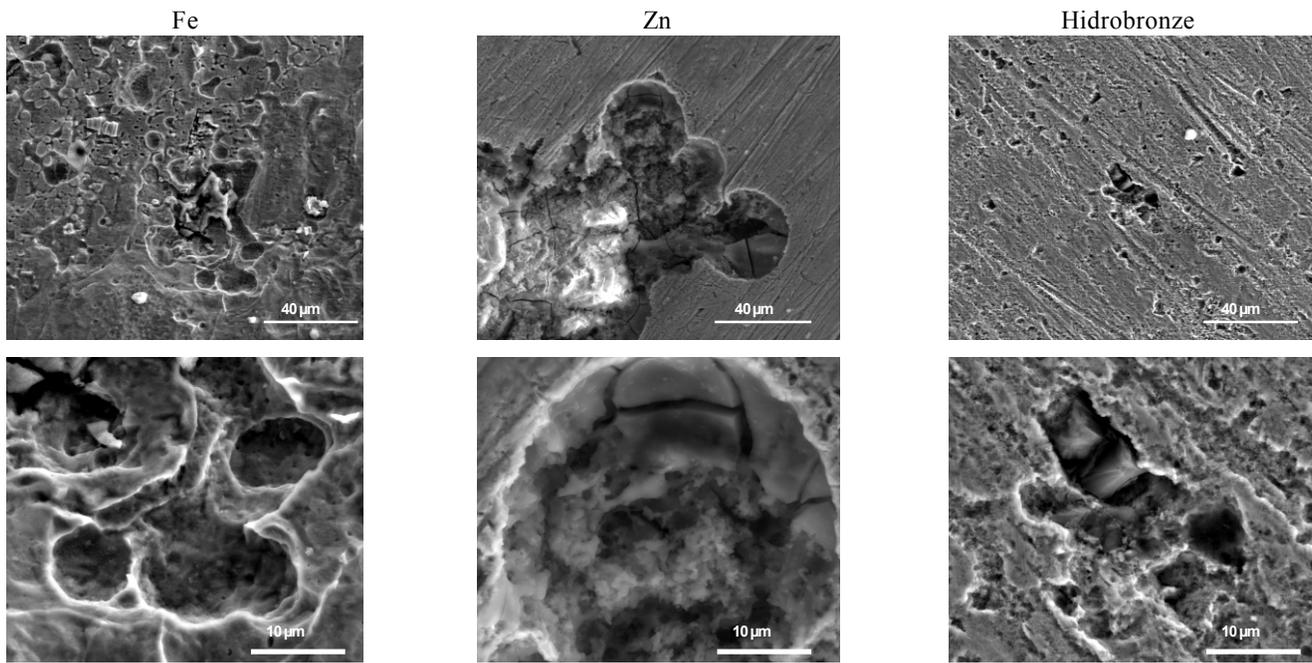
After accumulated deposits removal from different metallic samples SEM/ESEM analyses showed the attack morphology for high magnifications on the different substrata, shown in Fig. 9. The attack morphology seems to depend not only from the prevalent microbe in the biofilm and respective counting but especially from the substratum susceptibility and metallurgical structure. Fe and Zn in Figs. a and b) produced hemispherical localised attack with corrosion products accumulated on the bottom, while the localised attack of the hidrobronzze attack shown in Fig. 9 c) reveals the alloy crystallography.

Figure 9. Underlying alterations after biofilm and corrosion product elimination.

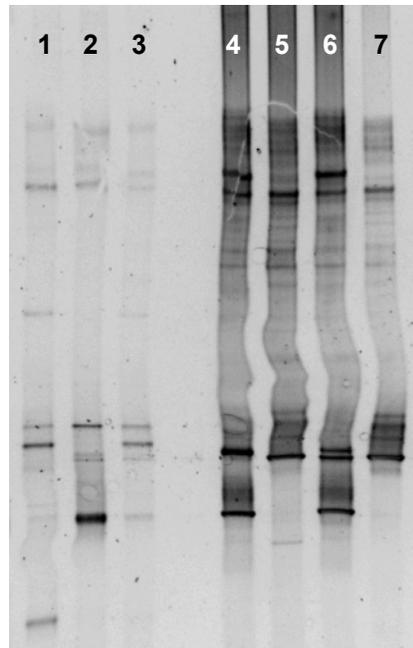
The DGGE fingerprinting of the PCR products of planktonic and biofilm microorganisms is shown in Fig. 10 and its cluster analysis in Fig. 11. The band positions in the DGGE profile corresponded to a population of individual microbial identities. At least 72 bands can be distinguished in the gel.

Figure 10. DGGE fingerprinting gel.

REF: 1= total planktonic; 2= total sessile on Fe; 3= total sessile on Zn; 4= culturable sessile on Fe; 5= culturable sessile on PP; 6= culturable sessile on Zn; 7= culturable sessile on Hidrobronze.

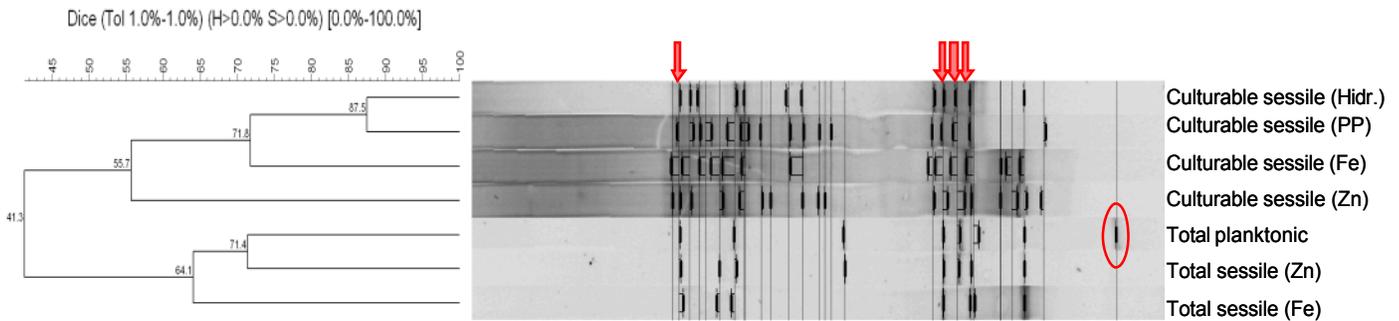
The dendrogram of DGGE profiles (Fig.11), clearly show two groups, one for culturables and one for total communities. Considering that each band represents a microbial population, it can be noticed that only those populations identified with red arrows were found on all the samples.

Figure 11. Cluster analysis of the DGGE band profiles. The differences between the DGGE patterns are indicated by similarity percentage.

The dendrogram of DGGE profiles clearly shows two groups with a relatively low similarity (41.3 %). One of them, containing the sessile culturable communities, shows a closer association between the communities grown on hydrobronze and PP (87.5 %). The other group includes the total communities (sessile and planktonic). The number of DGGE bands in the gel can be used as an indication of community richness. We found more bands in lanes corresponding to culturable populations of sessile bacteria than those obtained for the total sessile populations on all surfaces. In this case the higher number of bands could be associated with the enhancement of the number of copy of bacterial DNA due to culturing.

It is worth noting that one intense band (black circle, Fig.11) is present only in the total planktonic community and can not be distinguished in any other lane. This could be related with a population present in the water, which is unable to grow attached to any of the assayed materials.
