## Livestock management and dam removal allowed the recovery of an aquatic habitat for endangered frog and fish species in Argentinian Patagonia

**SUMMARY:** Placement of fencing around a stream to prevent livestock damage and water flow restoration via removal of a dam allowed riparian and aquatic vegetation recovery (76%) in less than one month. This subsequently allowed the reintroduction of a Critically Endangered frog as well as protection of an Endangered fish species.

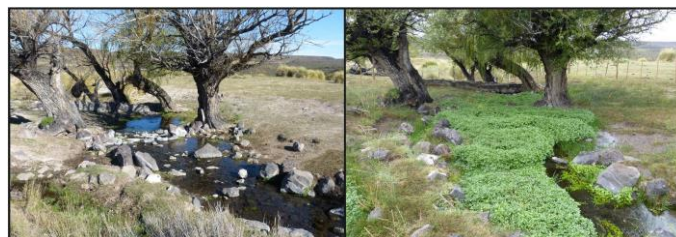
**Figure 1.** El Destacamento, before (left) and after (right) habitat restoration.

**CONSEQUENCES & DISCUSSION:** Riparian and aquatic vegetation showed an increase in cover (comprising mainly *Hydrocotyle bonariensis* and *Cardamine* spp.) of up to 76% in one month (Figure 1). Vegetation cover showed significant differences ( $p < 0.001$ ) when comparing percentages observed before (average 5%, range 0-50%) and after both interventions (average 81%, range 10-100%). Although we did not measure it, there was also a visible increase of vegetation cover in the surrounding grassland. We visually recorded a great increase in the abundance of the snail *H. rionegrensis* on the site. The dam rupture restored the original width (from 5 m to 2 m), depth (from 1.5 m to 0.5 m), and water flow of the stream. We consider that the increase in vegetation covering the streams' perimeter and a large percentage of the water offers key species both suitable breeding habitat and a refuge from predation by birds. This conservation action gives us valuable information about the potential speed of restoring this habitat to be considered in future Action Plans for other endemic species.
