International Congress of Science and Technology of Metallurgy and Materials, SAM -
CONAMET 2013

Corrosion of painted galvaneal steel

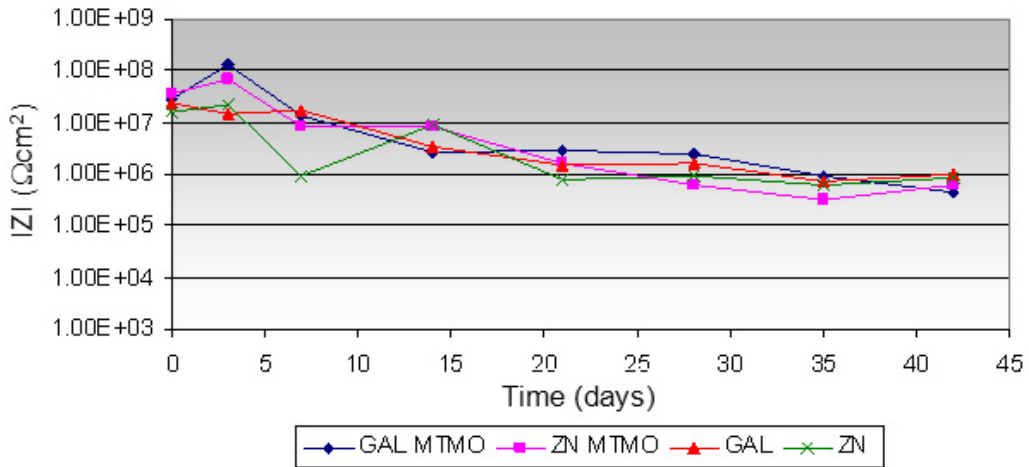
Fig. 7. Evolution of the impedance module at low frequency during exposure in HC.

With regard to the EIS measurements carried out on the intact area of the samples periodically taken of from the HC, Fig 7 shows that the behavior of all the studied systems was quite similar.

Fluctuations in the impedance values occurring in some cases were attributed to the dynamic behavior of the interfacial processes taking place in these systems, since, when the electrolyte diffuses through the coating and reaches the metal substrate, the total impedance value may drop. However, due to its dielectric characteristic, most of the formed corrosion products seal these faults causing the impedance to increase again. As the exposure time increased, the trend in all cases was that the impedance module decreased, stabilizing at values close to $8 \times 10^5 \Omega \text{cm}^2$ at 42 days exposure. Such stabilization indicates that the deterioration process of the involved metal/paint system was very slow.

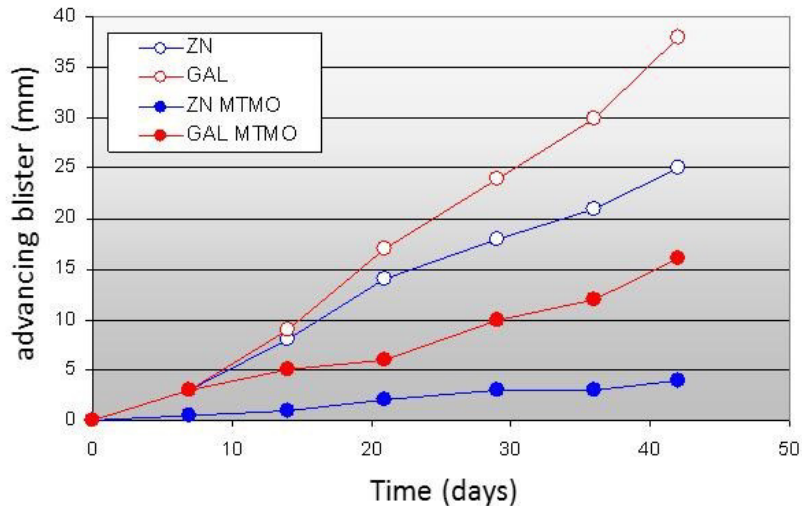
Fig. 8. Blistering evolution from the cut as a function of the exposure time in SSC.

In this test, clear differences were observed with respect to the blistering evolution from the cut. Delamination rate was nearly linear over 42 days testing. No pre-treated samples had a higher delamination rate, with values of 0.9 and 0.6 mm/day for GAL and ZN samples, respectively (Fig 8).

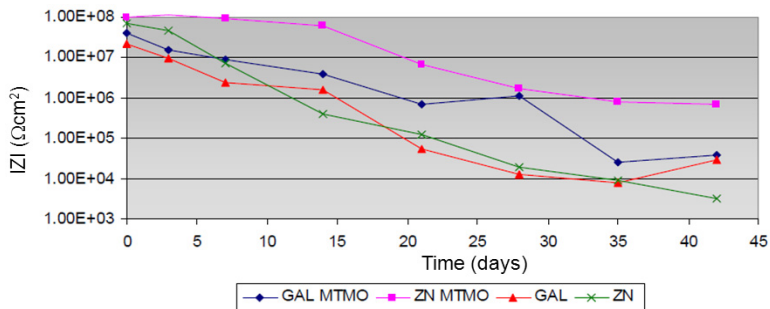
Fig. 11. Evolution of the impedance module at low frequency during exposure in SSC

The periodical evaluation by EIS showed differences in the impedance modulus evolution at different test times (Fig 11). The best performance corresponded to the ZN-MTMO samples since even though there was a decrease of $|Z|$ after 15 days of test, the values remained high throughout the test. The poor protective behavior was exhibited by the samples without treatment. In those cases, the decrease of the impedance module was very significant, reaching values similar to those of uncoated zinc before the 30 days of test. This behavior difference was ascribed to the fact that, in samples without pre-treatment, the electrolyte reached the substrate due to adhesion failures in some isolated places where small blisters were formed, significantly reducing the system impedance.
