Effect on temporary protection and adhesion promoter of silane nanofilms applied on electro-galvanized steel

P.R. Seré^{a,b,1}, M. Banera^{b,c}, W.A. Egli^{a,1}, C.I. Elsner^{a,b,1}, A.R. Di Sarli^{a,1}, C. Deyá^{a,b,*}^a CIDEPINT: Centro de Investigación y Desarrollo en Tecnología de Pinturas (CICPBA- CONICET LA PLATA), Av. 52 s/n entre 121 y 122, 1900 La Plata, Argentina^b Facultad de Ingeniería, Universidad Nacional de La Plata, Av. 1 Esq. 47, 1900 La Plata, Argentina^c INIFTA: Instituto de Investigaciones Fisicoquímicas Teóricas y Aplicadas (UNLP- CONICET LA PLATA), Calle 64 y diagonal 113s/n, 1900 La Plata, Argentina

In this paper, the effectiveness of γ -mercaptopropyltrimethoxysilane (MTMO) films as temporary corrosion protection and adhesion promoter on electro-galvanized steel was studied. The films were synthesized from hydrolyzed MTMO with ethanol or methanol, applied by immersion on electro-galvanized steel and cured under different conditions. The porosity of the coating was evaluated by cyclic voltammetry, the corrosion behavior by polarization curves and the protection degree by exposure in the humidity and prohesion chambers. The films were characterized by scanni

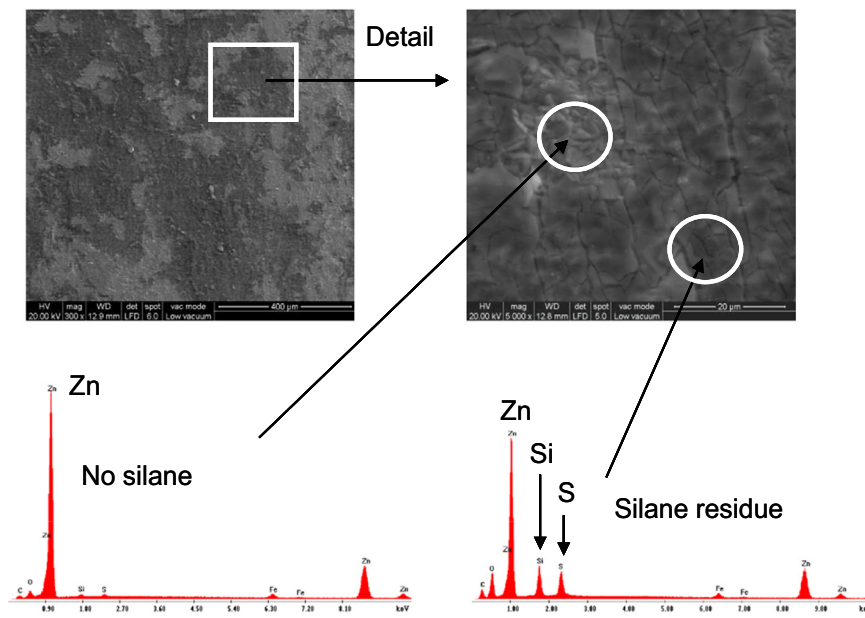
Fig. 10. SEM and EDS of the paint underneath area after adhesion test in PE8 sample.

In PE8 samples, the areas under the removed paint did not display any sign of this film since no Ti (from TiO₂) was detected by EDS, Fig. 10. MTMO was present only in some parts of the surface, while in the others neither S nor Si was detected, indicating that the adhesion at the silane film/metal interface was the main failure. In PM8 samples studied by EDS the presence of Ti was detected, therefore, the failure was of cohesion, i.e. between layers of the paint film, Fig. 11.
