International Journal of Adhesion & Adhesives

Behavior of two eco-compatible duplex systems used in the construction industry against corrosion

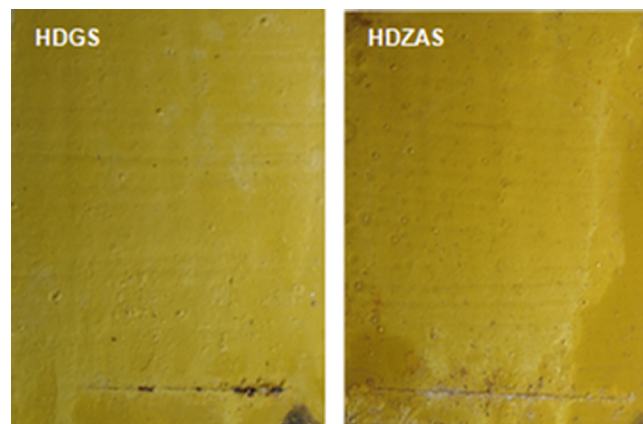
Fig. 4. Photograph of the samples after 150 days of exposure in HC.

All duplex systems featured very good behavior in HC. One hundred and fifty days after exposure and according to standard ASTM D 714, the level of blistering was 6F for all the cases (see Table 3 for the classification of the blistering degree). No marked influence of the pretreatment with MTMO was observed in this test (Fig. 4). However, in the painted HDGS samples 72 days after exposure, steel corrosion products appeared in the area where a cut had been done through the paint to reach the steel substrate. The HDZAS only presented white corrosion products, which were attributed to deterioration of the inorganic coating.

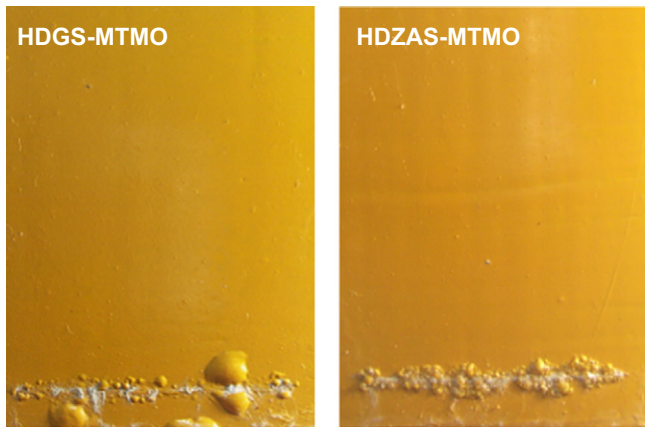
Fig. 6. Photograph of the samples after 42 days of exposure in SSC.

Fig. 6 shows the results after 42 days of exposure in the SSC. The undamaged samples' area presented no blisters or corrosion signs after the test.

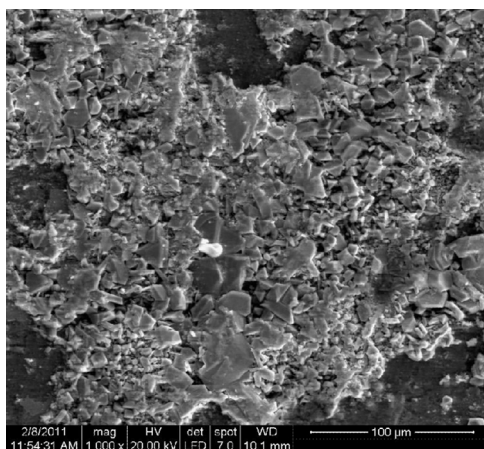
Fig. 9. SEM image of the HDGS sample after 42 days of exposure in SSC (1000 ×).

simonkolleite ($Zn_5(OH)_8Cl_2 \cdot H_2O$) [18–21]. Being very bulky, Fig. 9, this compound causes cleavage of the paint from the substrate in the areas where it is formed and increase pressure on adjacent areas, weakening the paint/substrate adhesion. Combined with a poor adhesion, that effect causes unsatisfactory protective ability in this medium. Conversely, when the electrolyte that contains anions Cl^- is in contact with the HDZAS, hydrozincite ($Zn_5(CO_3)_2(OH)_6$) is formed in the interdendritic zones and precipitates forming small acicular crystals, Fig. 10. Zinc aluminum carbonate ($Zn_6Al_2(OH)_{16}CO_3 \cdot 4H_2O$), the major corrosion product, is then formed onto all the surface. This compound has a crystalline and compact structure [22]. This fact, in conjunction with a better substrate/paint adhesion, makes the delamination progress much slower than in the HDGS. Pretreated with MTMO, the HDGS notably improves its adherence to the paint; this fact was revealed

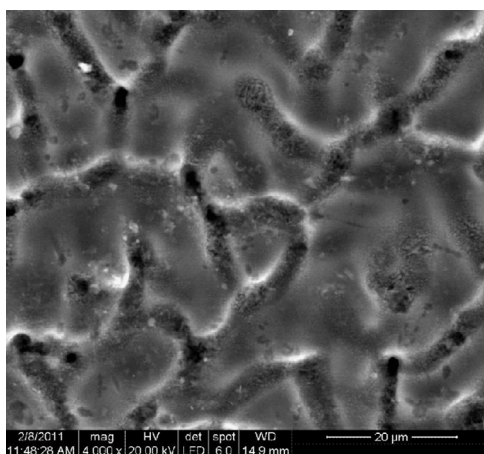
Fig. 10. SEM image of the HDZAS sample after 42 days of exposure in SSC (4000 ×).
